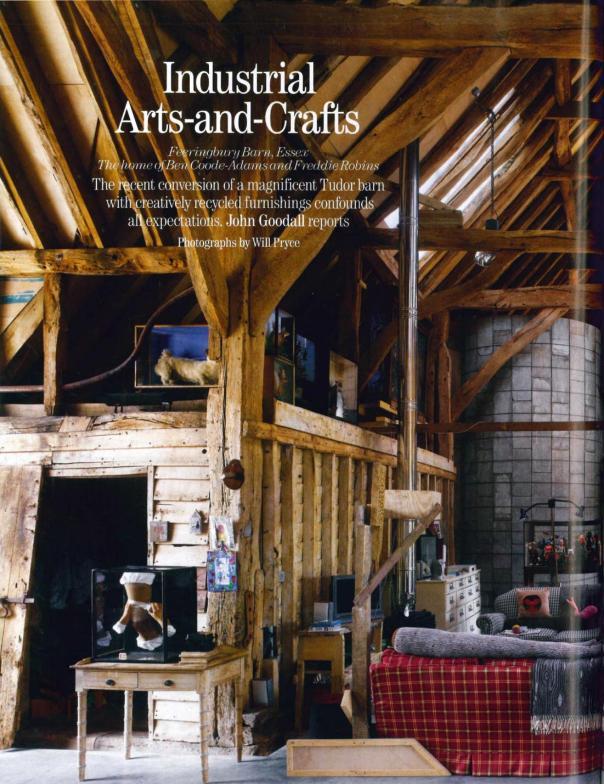
→ Fig 4 facing page: The workshop and studio space. The upper part of the wall separating it from the living area is glazed so the view along the roof remains open

The restrictions on internal divisions demanded that the conversion be boldly conceived. A single timber-framed partition wall divides the long interior into two roughly equal sections, but to preserve the main vista along the roof, the upper sections of this wall have not been solidly filled in. Built up on one side of the wall are large book stacks

that face onto the workshop and studio area in one half of the barn (Fig 4). The other half of the building is the house. It comprises an open living space sandwiched between the kitchen (built against the wall) and bedrooms (Fig 2) on two levels at the far end of the barn. Two of the concrete silos have been retained and moved to serve these rooms: one encases a spiral stair up to the first floor, the other two bathrooms. Beneath the poured-concrete floor is a heating system served by a woodchip boiler.
